# **Trip Report 2003 Annual Inspection of Site A/Plot M, Cook County, Illinois, Decontamination and Decommissioning Program Site**

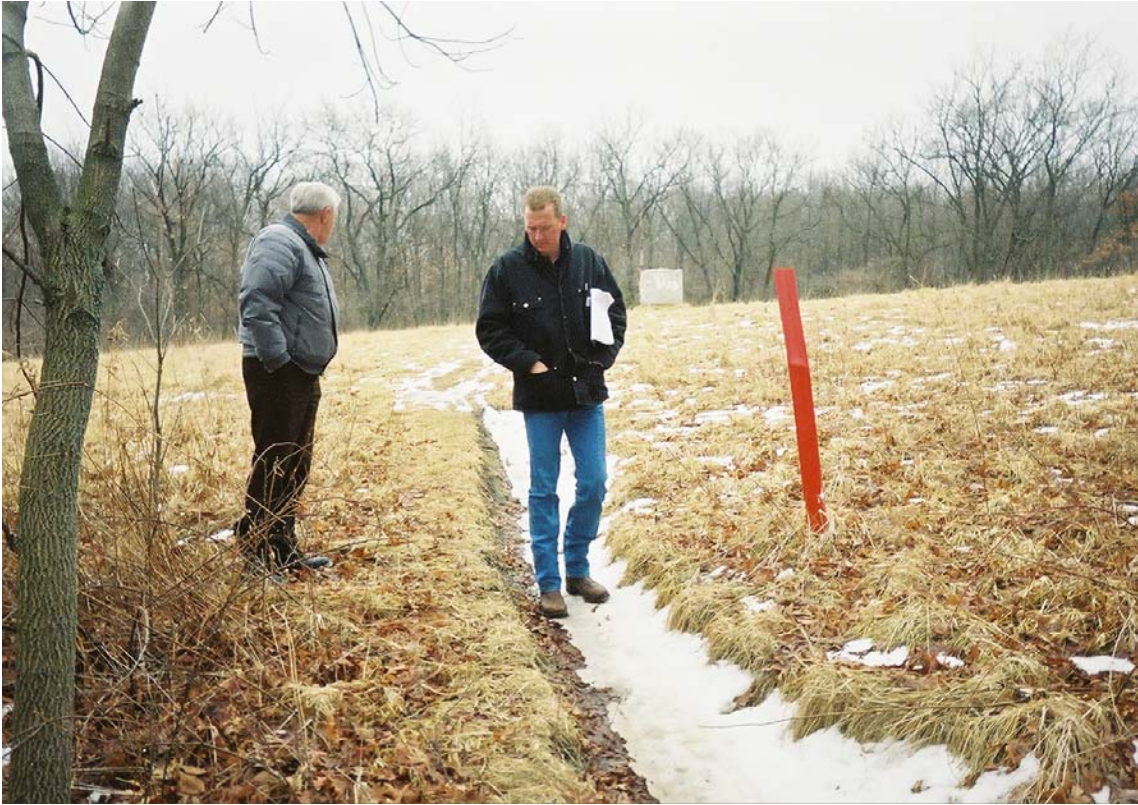
Erosion was noted along the paths crossing Plot M between the monument and the north, south, and west sides of the site (PL-1 and PL-2). The cell is not yet threatened but erosion is approximately one foot deep and the earth cover over the concrete cap is only two feet thick. Although erosion does not appear to have increased appreciably during the past year, the LTSM Program should consider controlling measures to reduce the likelihood of the concrete cap becoming exposed. The ANL representative requested the Palos Forest Preserve District repair the erosion in 2002 but the work had not been conducted.

SAM 03/2003. PL-1. Norbert Golchert and Mark Reed inspecting erosion on Plot M.

**Recommendation:** Enough traffic passes over these paths to preclude successfully repairing the erosion by filling the depression with soil and reseeding. Therefore, inspectors recommend placing crushed rock in the depression mixed with soil, and reseeding. A letter should be written to the Palos Forest Preserve District requesting them to repair the erosion.

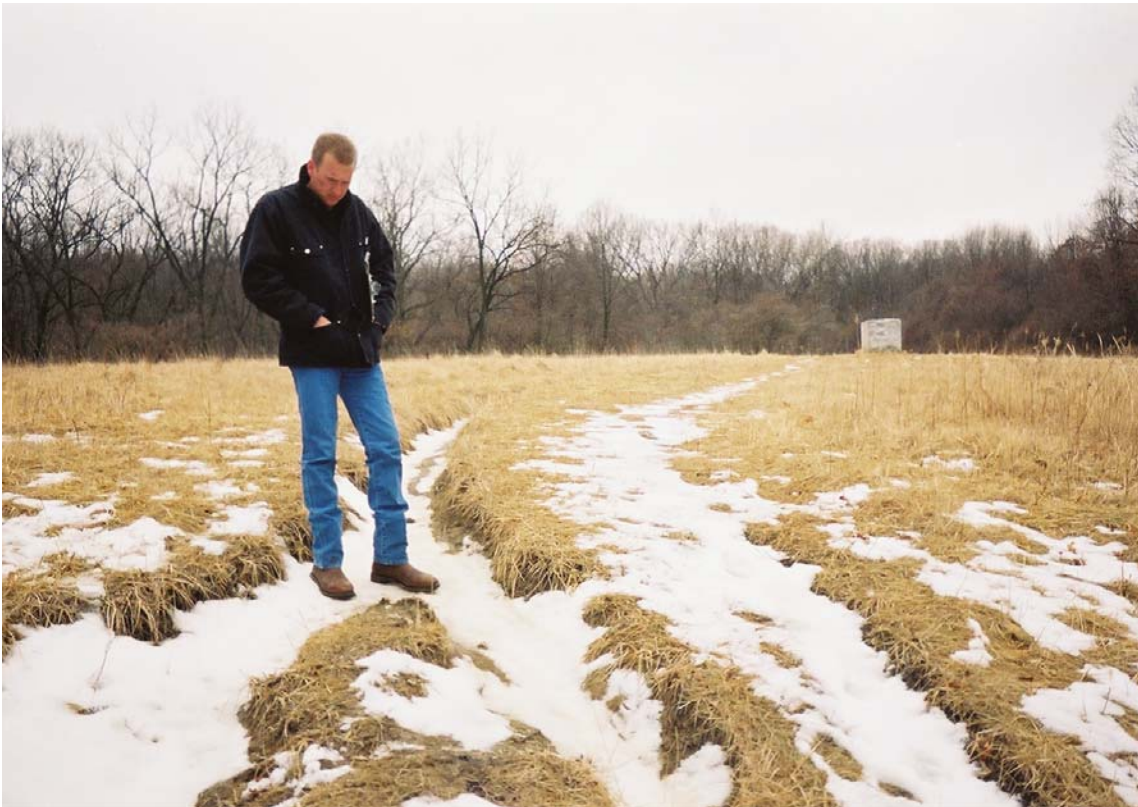
SAM 03/2003. PL-2. Mark Reed inspecting erosion trail on Plot M.
